## ARBORICULTURAL REPORT

### Report on alleged subsidence damage at 8 St Gabriel's Road, Billingshurst, RH14 9TX

**Arboricultural opinion on alleged subsidence damage at 8 St Gabriel's Road,  
Billingshurst, RH14 9TX.**

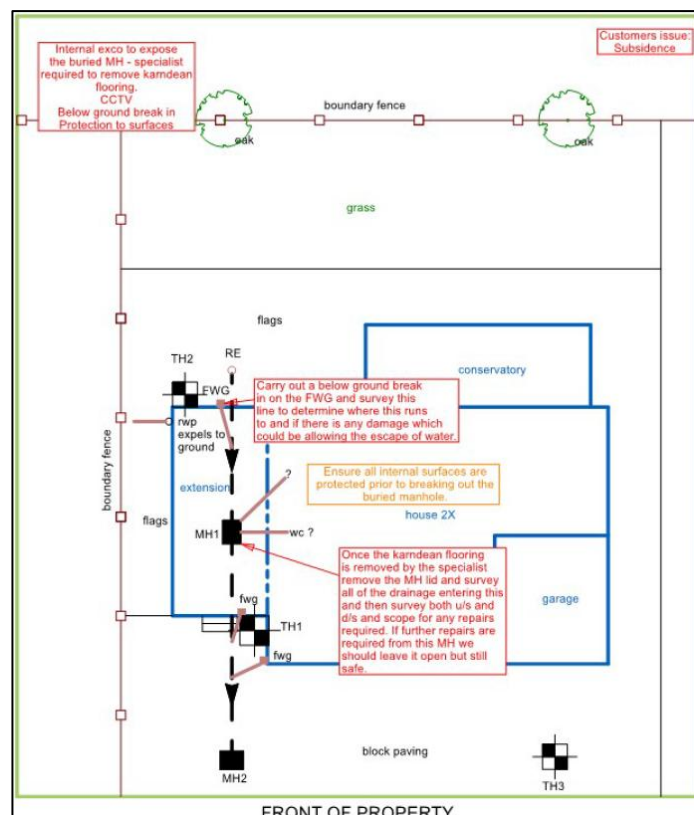
**Figure 1.** Site plan prepared by Auger to show locations of trial pits/boreholes (TH1 – TH3).

- 2.2 Auger visited the property on 2<sup>nd</sup> November 2020 and issued a report on 3<sup>rd</sup> November 2020. Three trial holes were opened; TH1 at the junction of the main house and garage at the front, TH2 at the rear left corner of the garage, and TH3 in the front drive (Figure 1).

- 2.3 In TH1 it appeared that there were no foundations, but that the garage had been constructed off a 200mm deep concrete slab. The soil below the slab was described as 'moist firm brown sandy fine to coarse gravelly silty CLAY' to a depth of 0.7m where it transitioned to 'moist very stiff brown fine to medium gravelly silty CLAY' to 2.2m. Below 2.2m to the end of the trial hole

at 3.1m the soil was 'moist very stiff brown silty CLAY'. The soil was tested for stiffness on site using a shear vane, as greater stiffness is an indicator to increasing dryness. Values in excess of 100kPa are regarded as signifying the presence of significant desiccation (the level of drying typically associated with tree-caused clay-shrinkage subsidence). Recorded values increased from 24kPa at 0.2m to 120kPa at 1.7m to 3.1m. Laboratory tests confirmed that the clay below the concrete slab had a medium volume change potential (as defined by NHBC Chapter 4.2) with a plasticity index in the range 22 – 29%. Soil suction tests revealed that the clay at 1.2m was severely desiccated (as defined by BRE Digest 241), with a value of 472kPa, and that the clay at 2.2m was very severely desiccated (4730kPa). The result at 2.2m suggests that the dryness of the soil was significantly outside of normal parameters, which either represents an abnormality, or means that the clay was exceptionally dry. Four very thin live roots at a depth of 0.7m were identified as being Quercus (oak).

- 2.4 In TH2 foundations were established to be 700mm deep. The soil below foundations was described as 'moist very stiff brown sandy fine to medium gravelly silty CLAY' which transitioned to 'moist very stiff greyish brown silty CLAY' at 2.2m to the end of the trial hole at 2.6m. Shear vane readings were all at 120kPa. Laboratory tests confirmed that the clay below foundations had a medium volume change potential with a plasticity index in the range 21 – 33%. Soil suction tests revealed very severe desiccation at 0.7 and 1.7m depth, but as for TH1 values were exceptionally high (3290 - 5100kPa). Two live roots at a depth of 0.7m were tentatively identified by Richardson's Botanical Identifications as being Quercus (oak), and a further two live roots at 1.2m were identified as oak.

- 2.5 A remote borehole TH3 was opened in the front drive and the soil profile was similar to that recorded for TH2, with shear vane readings all at 120kPa and plasticity index in the range 23 – 36% indicating medium volume change potential clay. However, soil suction values were all in the normal range expected of an un-desiccated clay (37 – 64kPa).

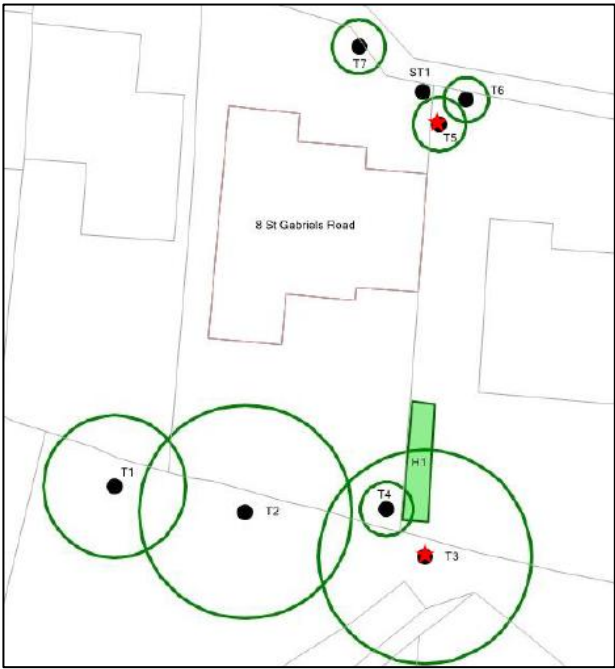
**Figure 2.** Site plan prepared by Environmental Services to show locations of trees near to the property.

- 2.6 An arboricultural report was prepared by Property Risk Inspection on 2<sup>nd</sup> February 2021, and, on the basis that the engineer was satisfied that damage had been caused by the action of vegetation, it recommended that the following trees should be removed: T3 oak (22m tall and 14.3m away from the rear of the house) and T5, a columnar cypress (7.1m tall and 3.1m from the front of the house). The locations of the various trees and shrubs is shown in Figure 2.

- 3.5 Option 1: fell T2 and T3. This option has the benefit that subsidence damage to the property will cease immediately, allowing superstructure repairs to be carried out, and avoiding the need for an expensive alternative engineered solution. The downside is that the amenity of the trees and their benefits to wildlife and the landscape will be lost. Any replacement trees will take a number of years to become established features in the landscape.

- 3.9 My recommendation is that oaks T2 and T3 should be felled. But I understand that this is a matter for the council to decide having weighed up the costs and benefits of each option.

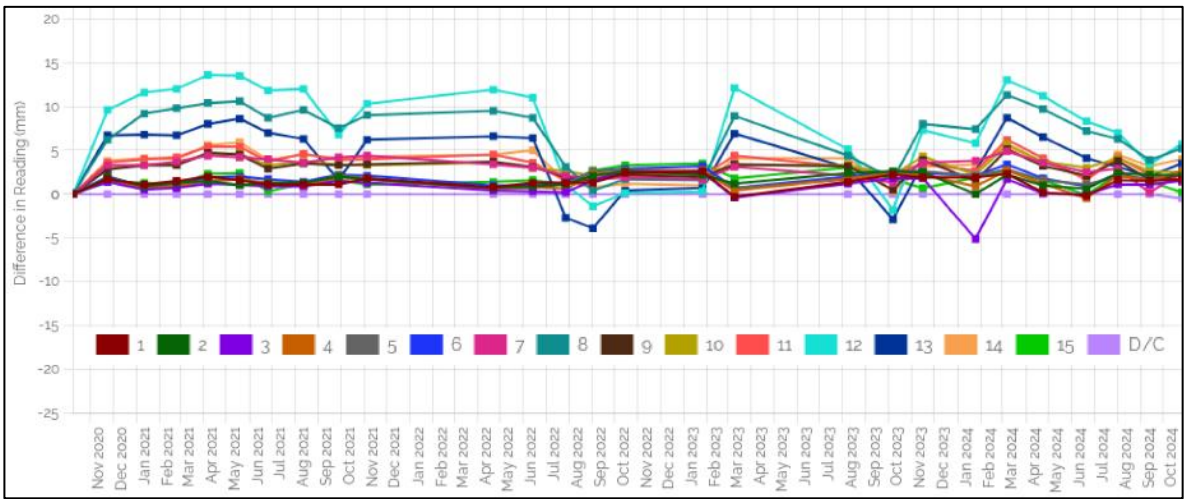
**Figure 3.** Level monitoring graphs for the period 8<sup>th</sup> October 2020 to 25<sup>th</sup> October 2024. More negative values indicate subsidence and more positive values indicate recovery from subsidence. The location of the monitoring markers is shown in the isometric sketch at Figure 4.

2.7 Monitoring of building levels commenced on 8<sup>th</sup> October 2020 and continued until 25<sup>th</sup> October 2024 (Figure 3). The readings confirmed a seasonal and cyclical pattern of foundation movement, with the building recovering from subsidence and moving upwards every winter from 2020 – 2023, and moving downwards every summer from 2021 – 2024. The degree of downward movement varied from year-to-year and was least in the relatively wet summer of 2021 (approx. 6mm max.) and worst in the dry summer of 2022 (max 15.4mm). The greatest relative movements were recorded at marker 10, at the rear left corner of the garage, and at markers 12 and 13 at the rear corners of the conservatory (Figure 4). The general direction of movement was down towards the rear, i.e. towards the oak trees on parish council land.

- 3.3 The desiccation in the soil caused the clay to shrink and thus support was withdrawn from the foundations of the property causing them to subside. The extent of the subsidence was identified by measuring the levels of the building over an extended period of time (2020 to 2024). A seasonal and cyclical pattern of movement was recorded, with foundations subsiding in summer as the clay dried out, and recovering in winter when trees were dormant and the soil could therefore re-wet. The maximum amplitude of foundation movements was slightly above 15mm, and it occurred at the rear, nearest to the oaks T2 and T3. The fact that markers 12 and 13 at the rear of the conservatory seem to be moving somewhat independently of marker 10 at the rear left corner of the garage strongly suggests that T2 was largely responsible for damage to the conservatory and T3 was responsible for damage to the garage.
